HPE 3PAR OS Upgrade Preparation Guide

This document is intended for use as a planning tool for HPE customers. It contains the HPE recommendations for HPE 3PAR OS upgrade process.

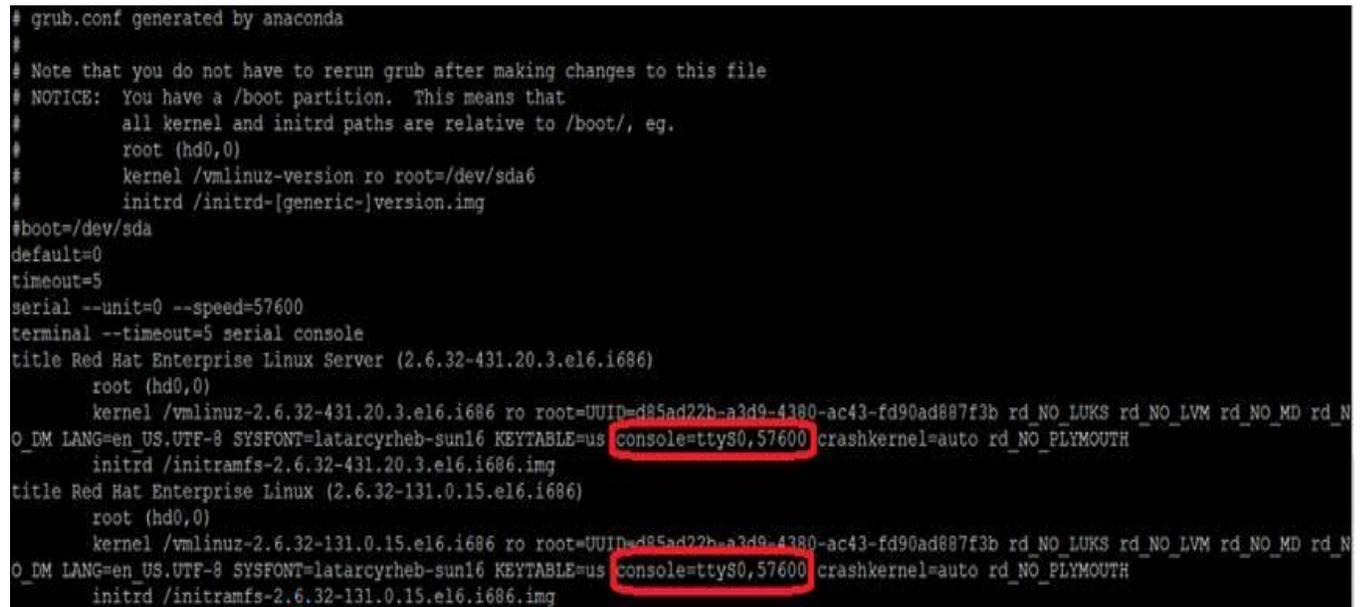
Step 5: Delete the entries for console within the grub.conf file as shown in the picture below and save the grub.conf file by using – **EscKey** followed by **:wq** and exit from the **grub.conf** file

Step 4: Edit the current grub.conf file by using the command – **vim /etc/grub.conf**
